Sakonnet Point Lighthouse Restoration

Owner: Friends of the Sakonnet Lighthouse, Inc.

Prime Consultant: Structures North Consulting Engineers, Inc.

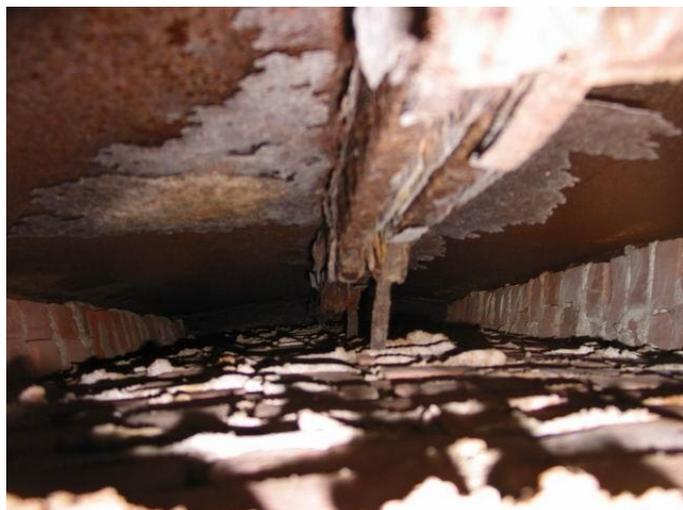
Concerned about the noted external movements, we made small excavations through the brick liner in order to view the back surfaces of the wall plates, and were shocked but not surprised to find that literally all of the bolts that once held the wall flanges together had either failed or had rusted away, and that the now no longer connected plates were being pried apart by large volumes of rust that was packed tightly between all of the flanges. Some of these had even cracked. It was immediately apparent that the entire cast iron shell had become a precarious stack of disconnected elements, most of which were held in place by no more than their own weight and whatever limited adhesion iron oxide can provide.

We also found many cracked iron floor plates, most of which we attributed to the accumulation of caked rust, but some of which may also have been attributable to the impact of waves at this unprotected site.

We determined that the only way to restore the iron plate shell to its original strength would be to fully expose it at the interior, remove all rust, re-drill bolt holes, and re-fasten the plate flanges together. This would unfortunately require the incremental removal and replacement of the brick liner that obscured the back surface of the iron, the same shell that provided the structures only lateral support. Therefore, we had to further weaken the already weakened structure before we could make it stronger. This would be done in sequential, vertical strips.

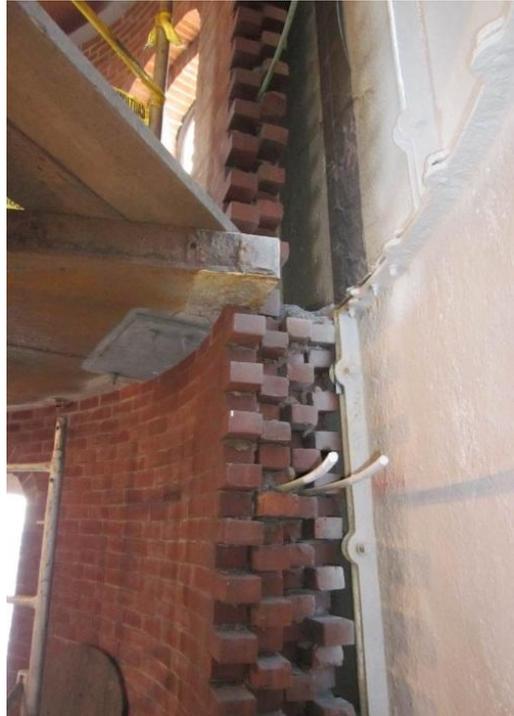
As the first section of brick was removed, it became immediately apparent that conditions were even worse than expected, and that the flanges had been rust-jacked apart in some places by more than an inch. They had also been necked down, frequently cracked, and their surfaces were roughened and irregular.

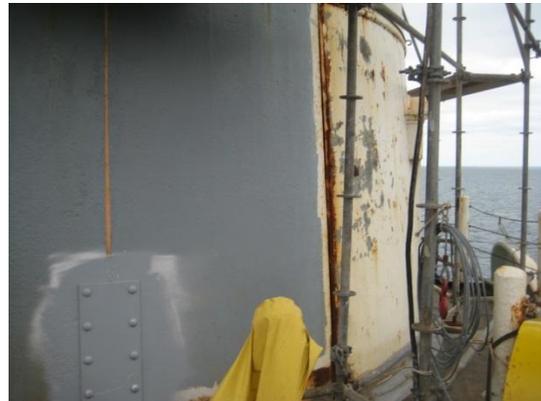
In many places, flange damage required that torques and bolt sizes be reduced to avoid additional damage to already cracked or thinly necked plate flanges, most prevalently at the first level, which had sustained the most severe corrosion and was ironically the most critically loaded. Curved tie plates were added at the base of this level to make up for these losses, and galvanized steel reinforcing was added circumferentially within the first and second levels of the brick liner to strengthen it.

We decided to change our design to use hot dip galvanized A325 bolts and three-piece plastic Korolath shims. Zinc is less noble than cast iron. The A325s would be epoxy painted, to prolong their lives, and the shims could be milled down in the field to accommodate the varying gap widths between the existing plates. In order to secure full bearing of the shims, the outer two pieces at each joint would be epoxy-adhered to the rough and pitted plate flange surfaces (like non-shrink grout under a bearing plate) and the milled shim would be wedged between them. The bolts were then installed and torqued to engage the shims and plates as friction-type connections, the required bolt tension being back-calculated from the equivalent capacity of the original low grade steel or iron bolts divided by the coefficient of friction between the plastic shims.

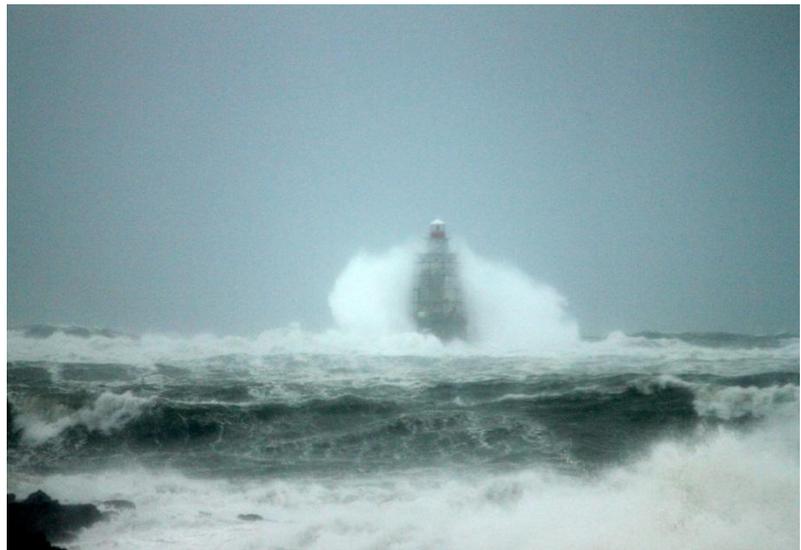
storm predictably blew out all of the window coverings, tore off the 3/8" plate steel door, and partially filled the lighthouse with water, all but mimicking the account by William Durfee in 1938. A follow-up inspection found absolutely no sign of structural damage of any type, and we were pleased that our work had withstood at least this initial test.
